ARBORIST REPORT

STATE BRIDGE RD SITE
State Bride Road
CITY OF JOHNS CREEK, GEORGIA

RE: Level 2 Arborist Inspection
State Bridge Rd – City of Johns Creek Ga Parcel: 11 094002990166

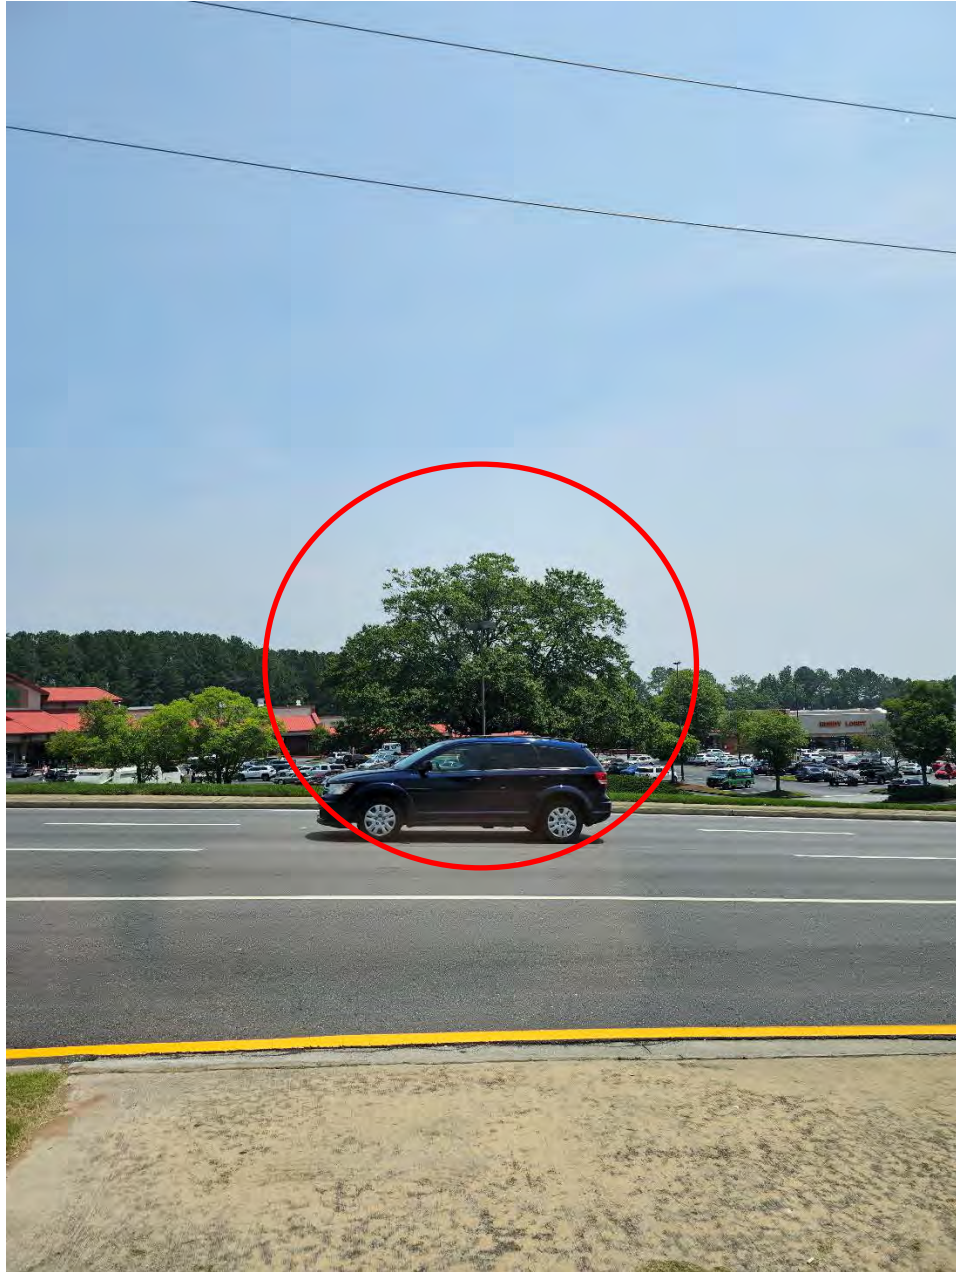
Figure 1. Tree located towards front of development

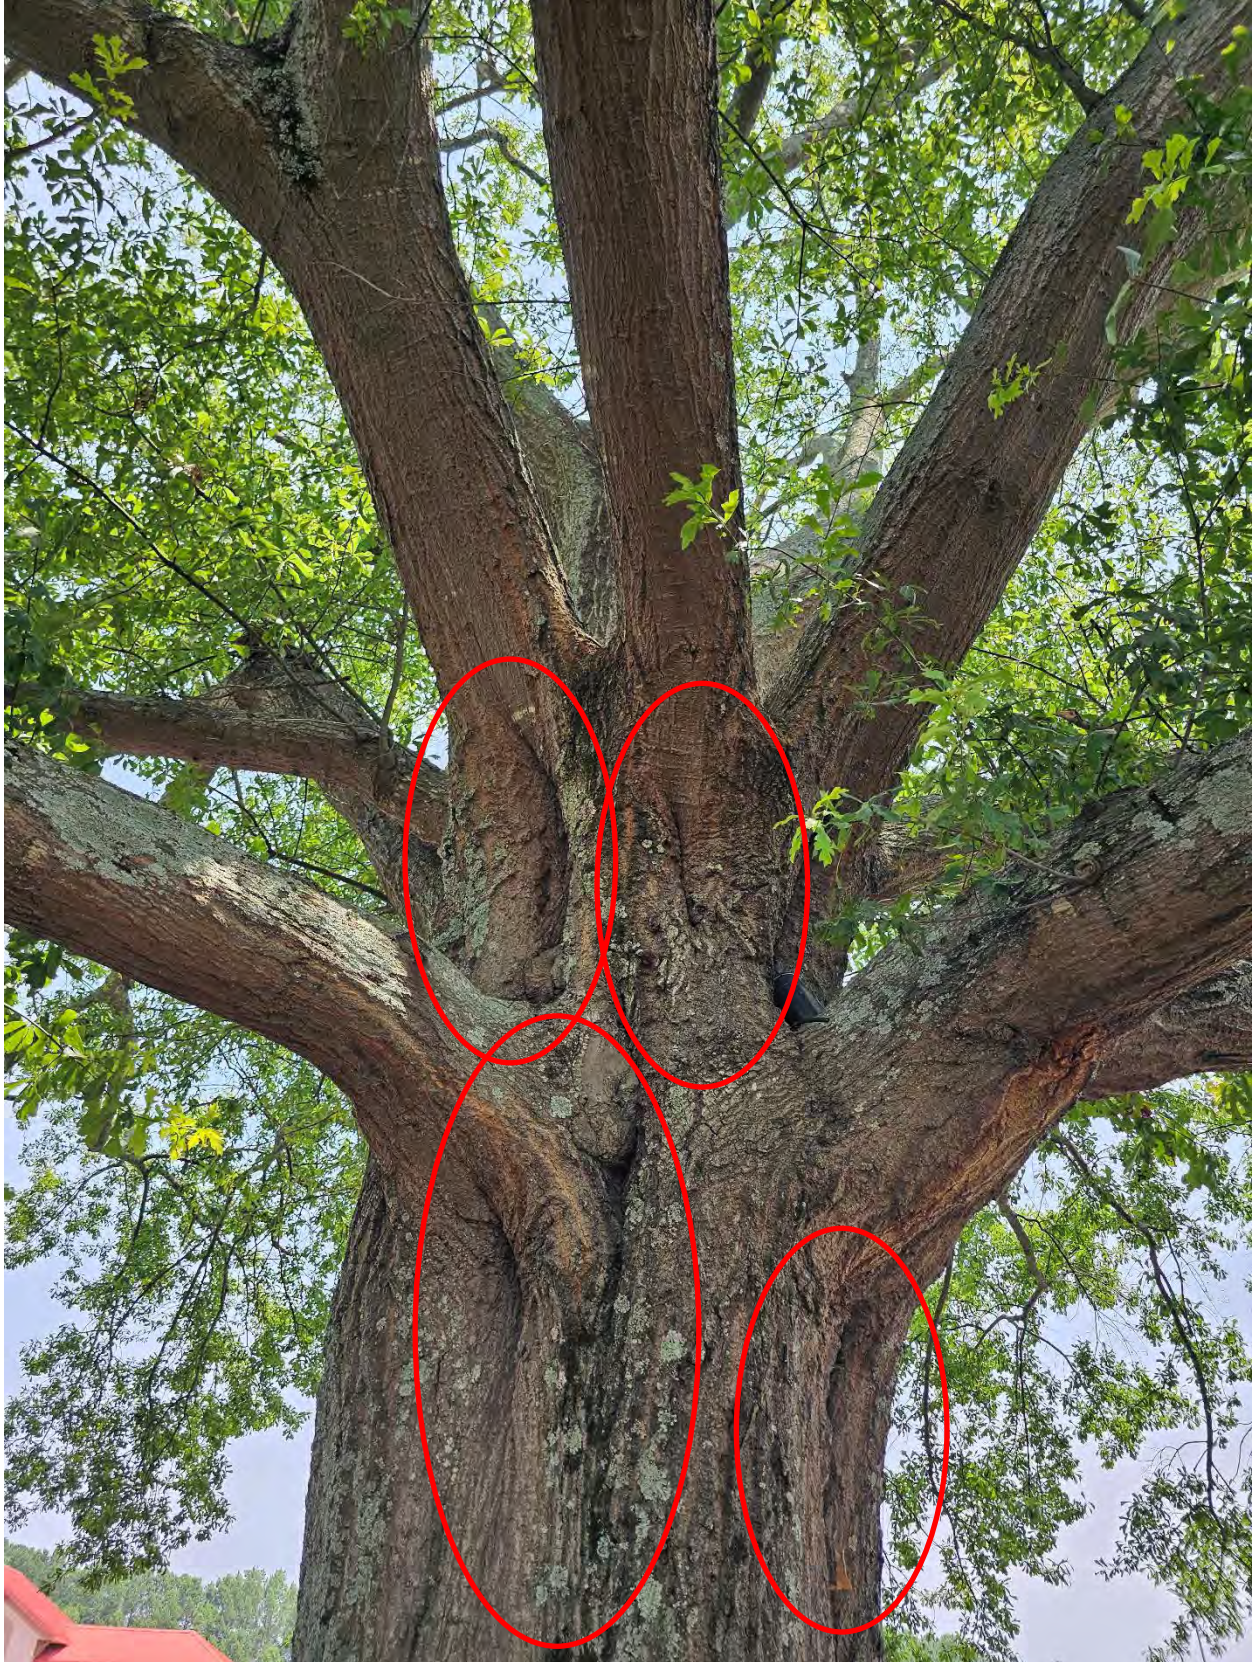
The tree was found to have a DBH of 49.5" and numerous signs of declining health. No site disturbance has occurred to affect any CRZ to the tree. While no current disturbances have occurred, it should be noted that critical root zones typically extend beyond the dripline and the impervious surfaces surrounding the tree reduce the ability of the tree to extend its critical root system. The tree has several areas of stem and limb decay as well as multiple portions of the crown present with thinning and chlorosis of the leaves. Multiple areas on the stem contain bark inclusion. **Bark Inclusions are serious tree defects that are very common, and often lead to breakage under low to medium loads.** They occur between two **co-dominant stems**, as they grow. The bark between the two stems included in the trunk, as the cambium advances year after year. This acts essentially as a wedge, pushing the stems apart, and thus producing an extremely weak union. This tree has passed the viable lifespan and has entered into decline that cannot be corrected and will ultimately die. Pictures further detailing the deficiencies are included.

Figure 2. Multiple areas of bark inclusion

Due to the severity of the structural deficiencies of these trees, there is no amount of engineering design improvements that can be made to assist in the longevity of the trees. It would be recommended to remove the tree to reduce the risk to the public and replace with a species of tree that would be more appropriate.

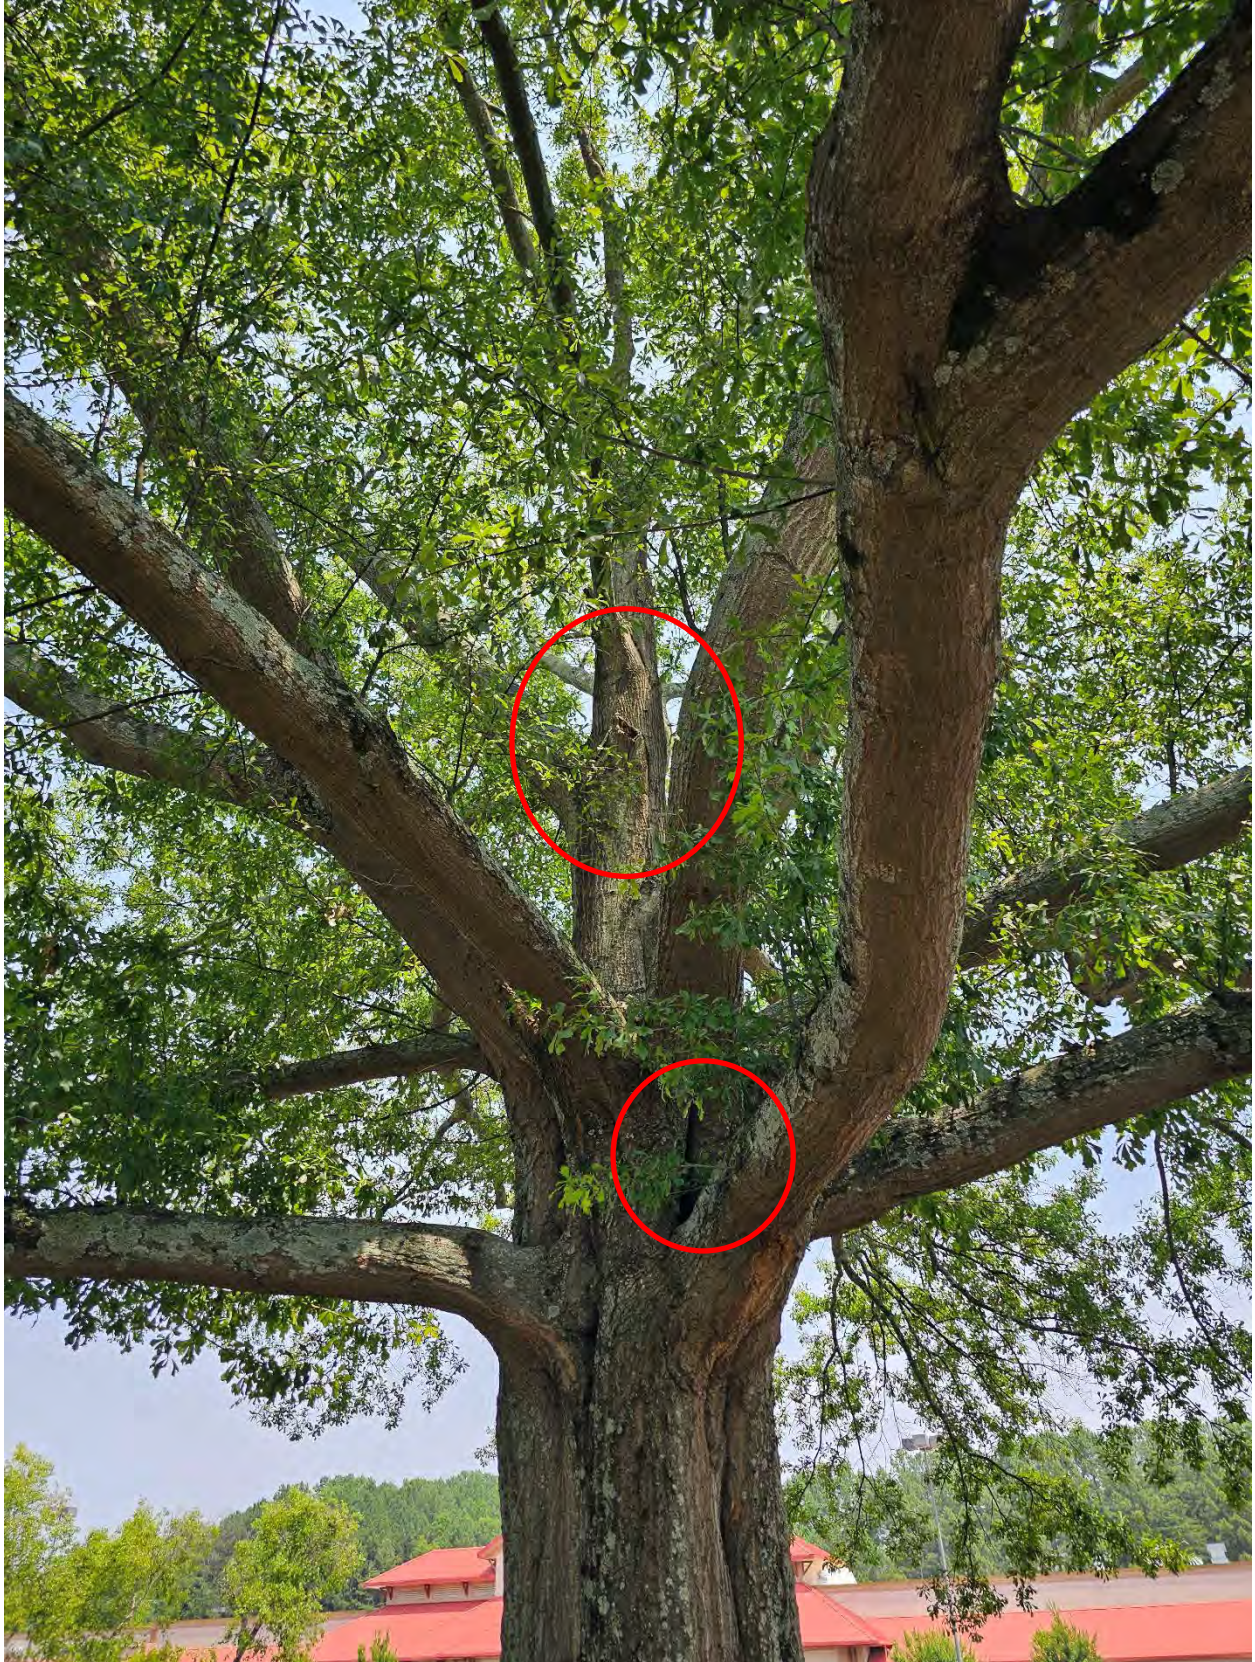
Figure 3. Decay in tree trunk

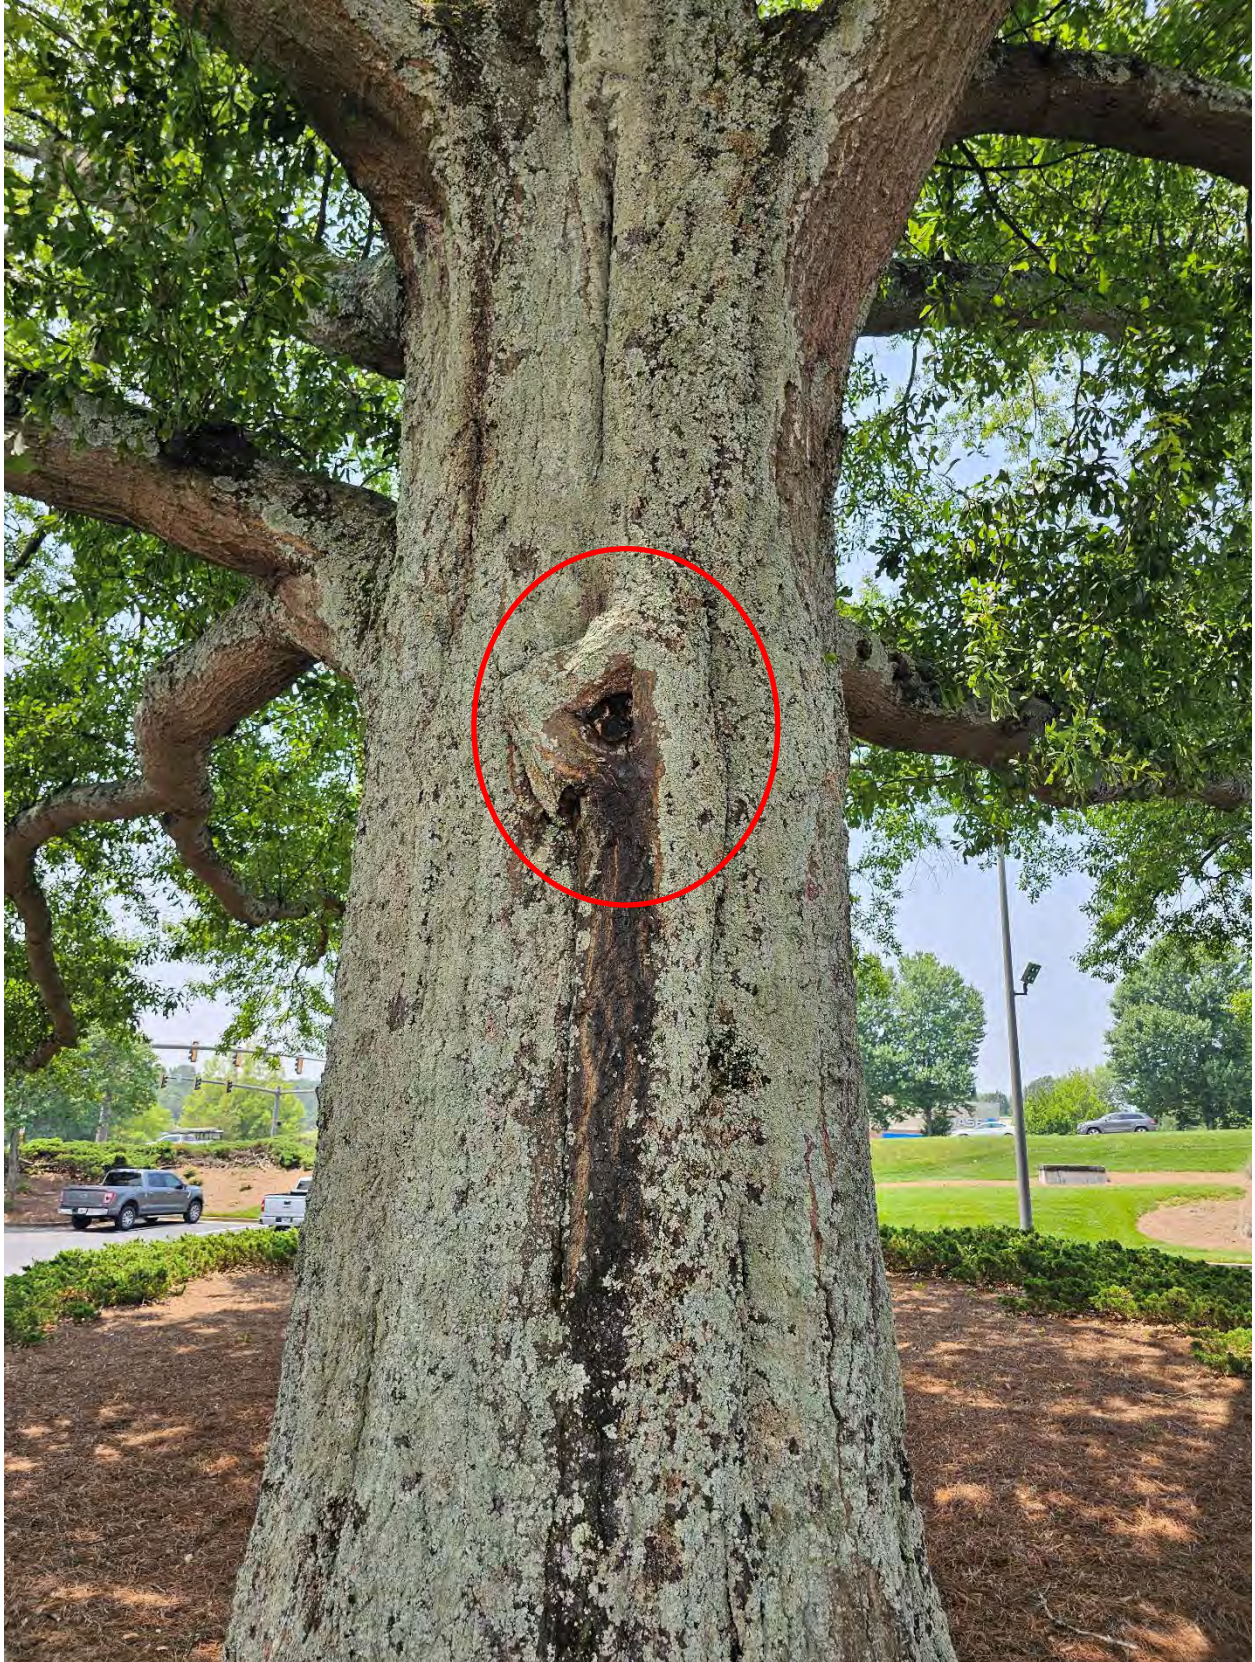
Figure 4. Decay in tree trunk

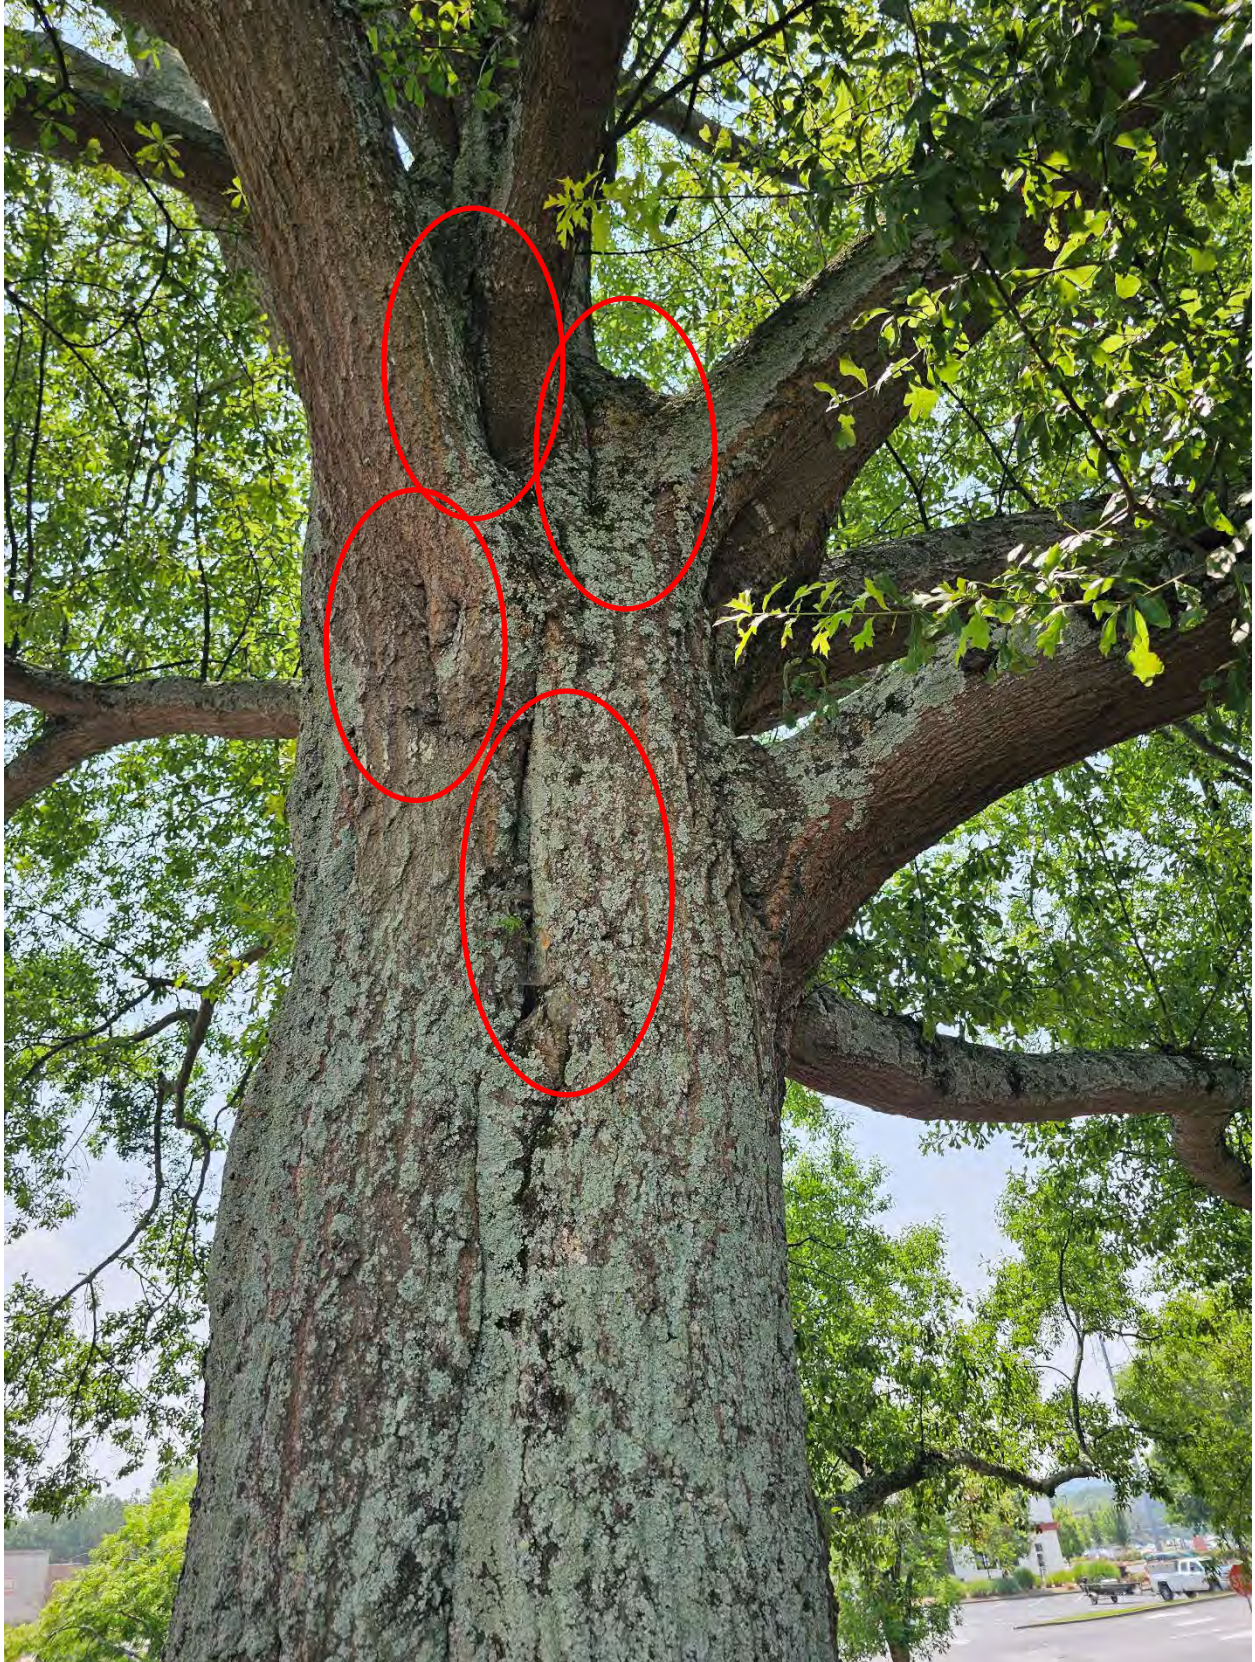
Figure 5. Multiple areas of bark inclusion

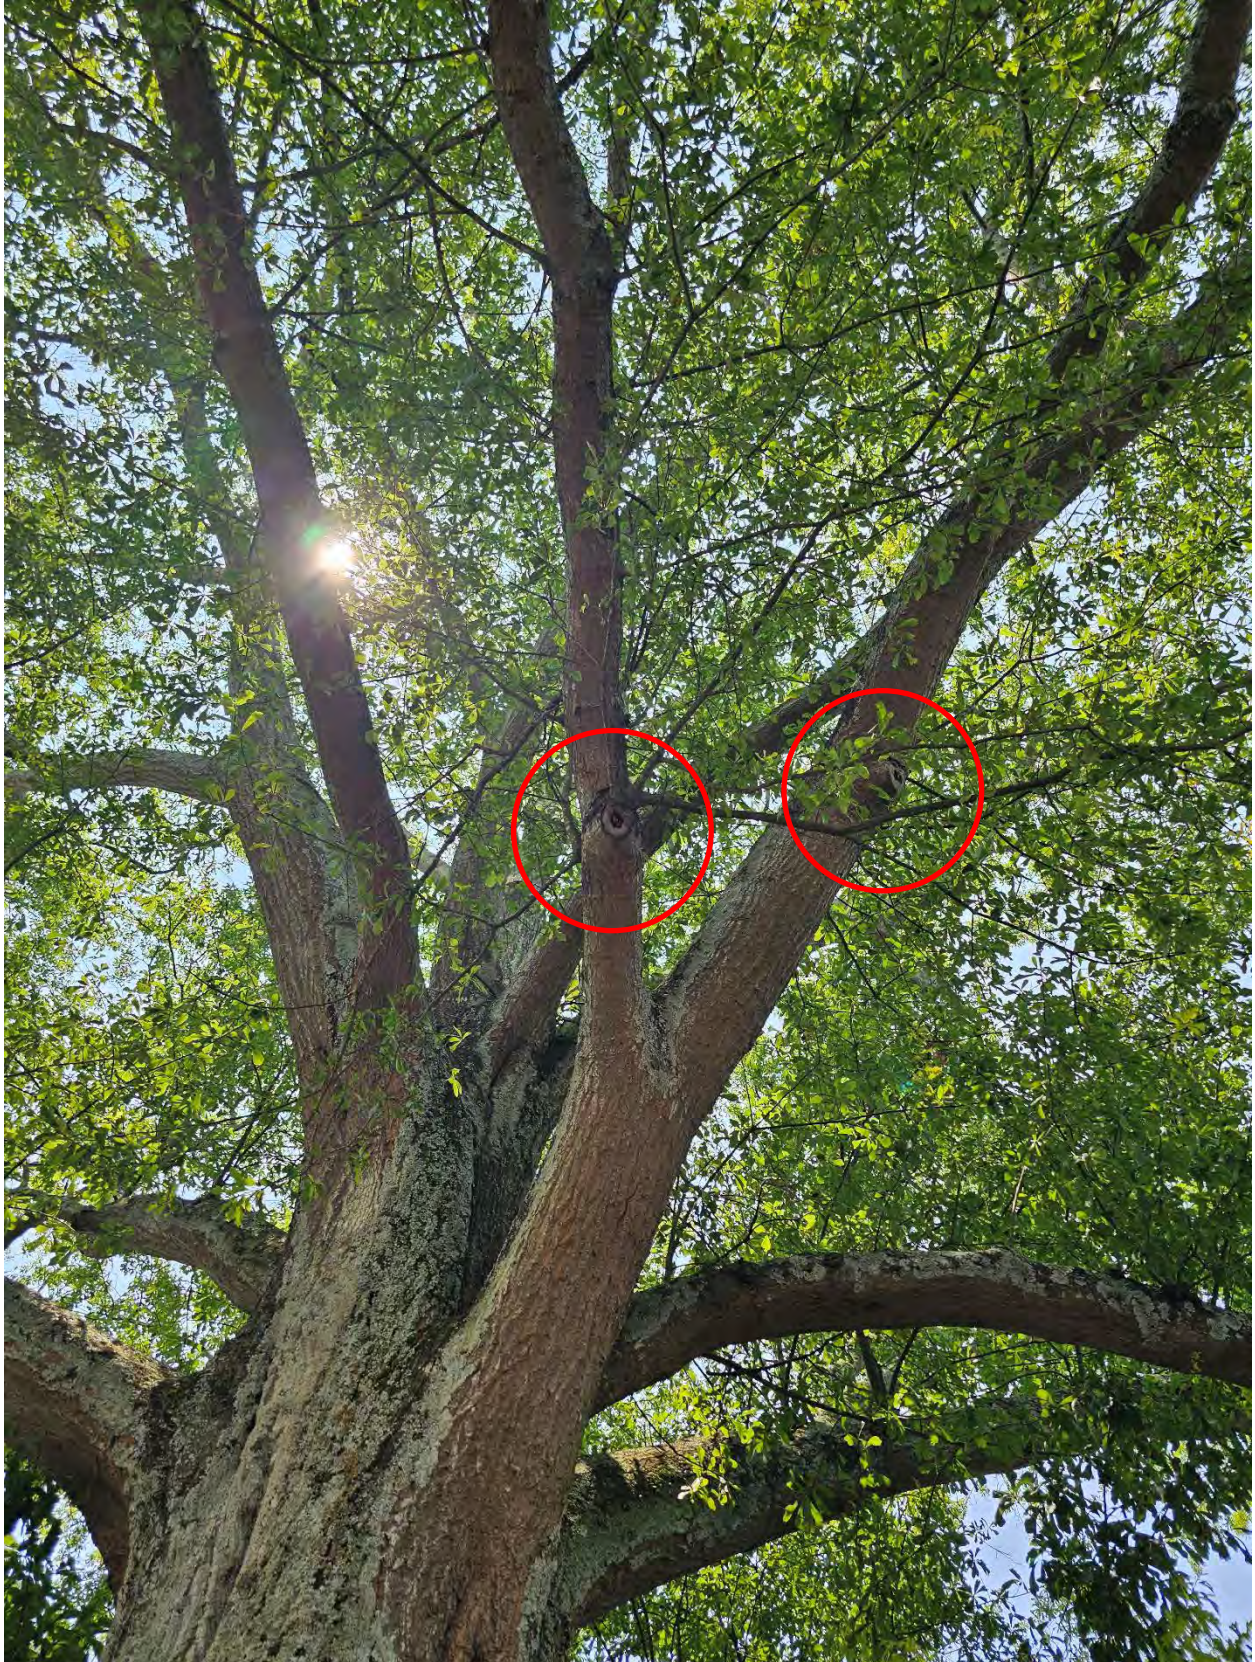
Figure 6. Decay in major limbs

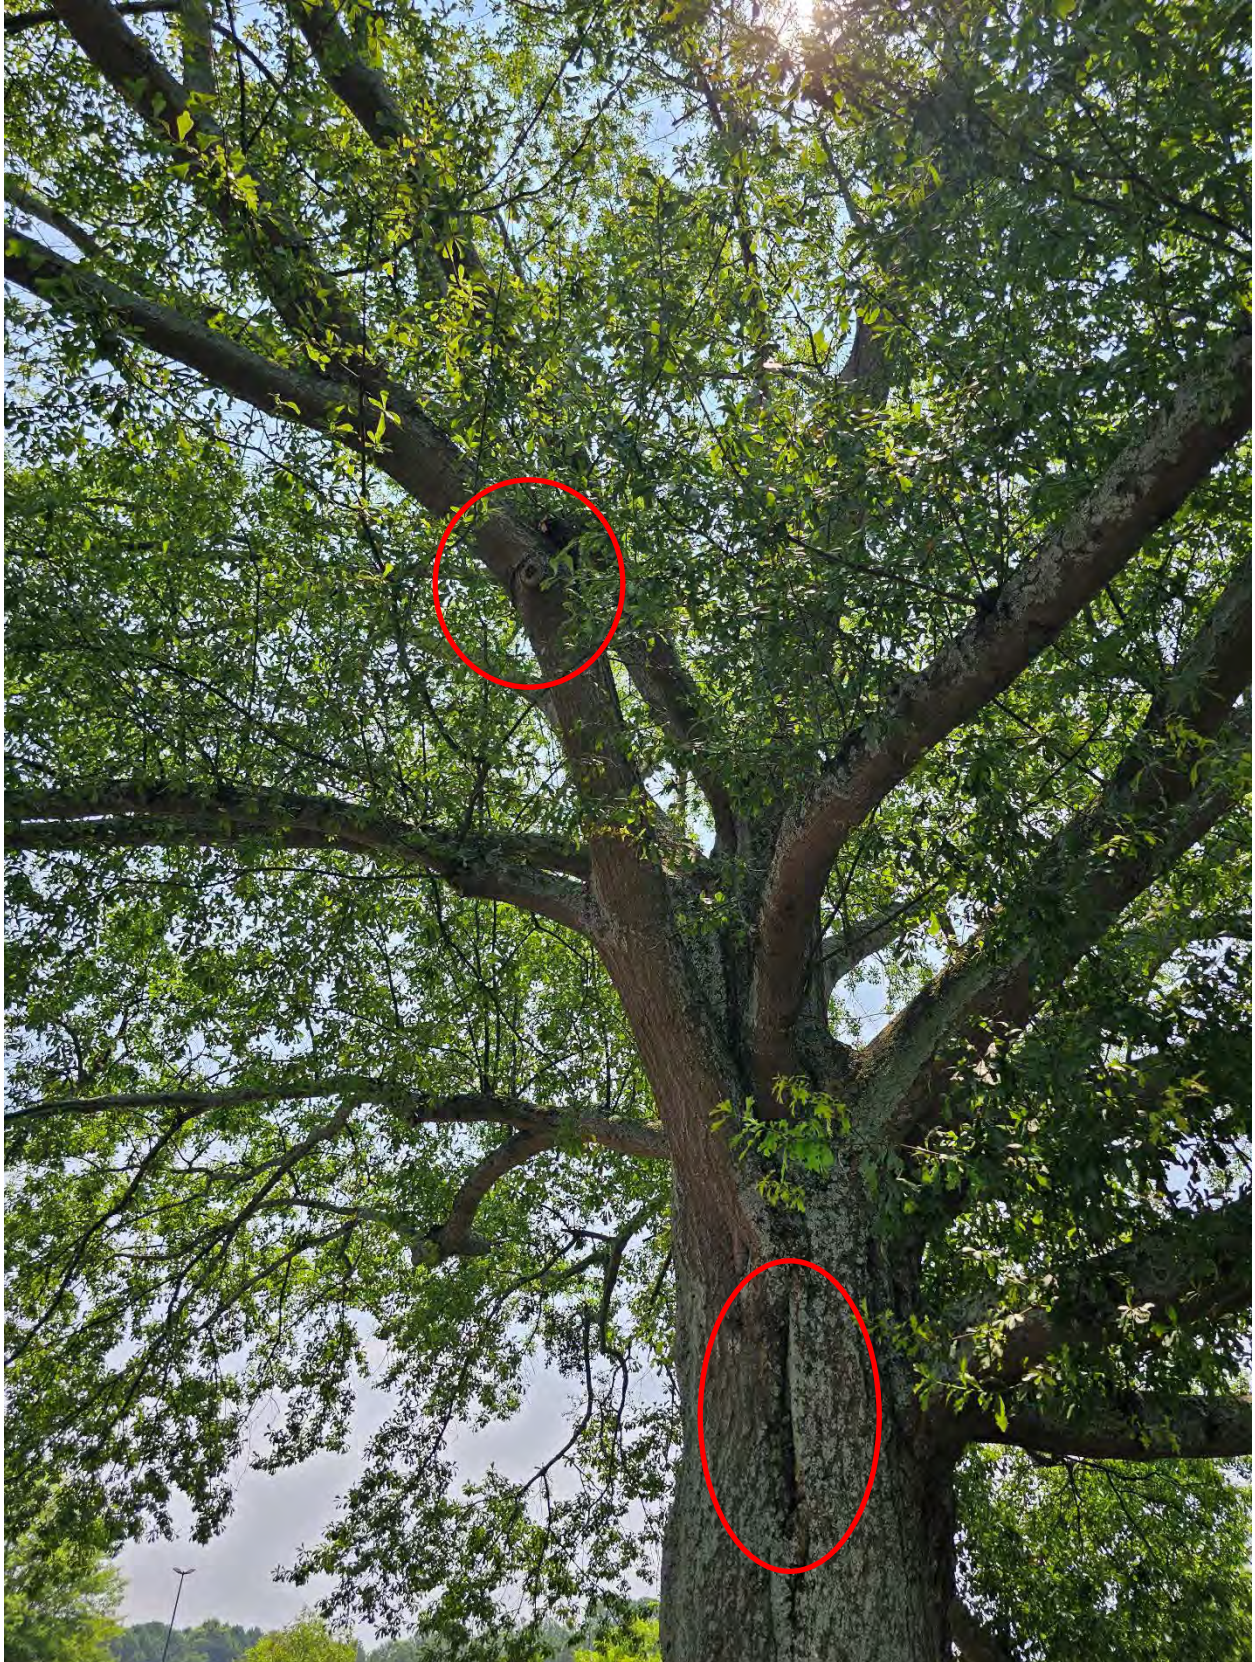
Figure 7. Decay on major limb and bark inclusion

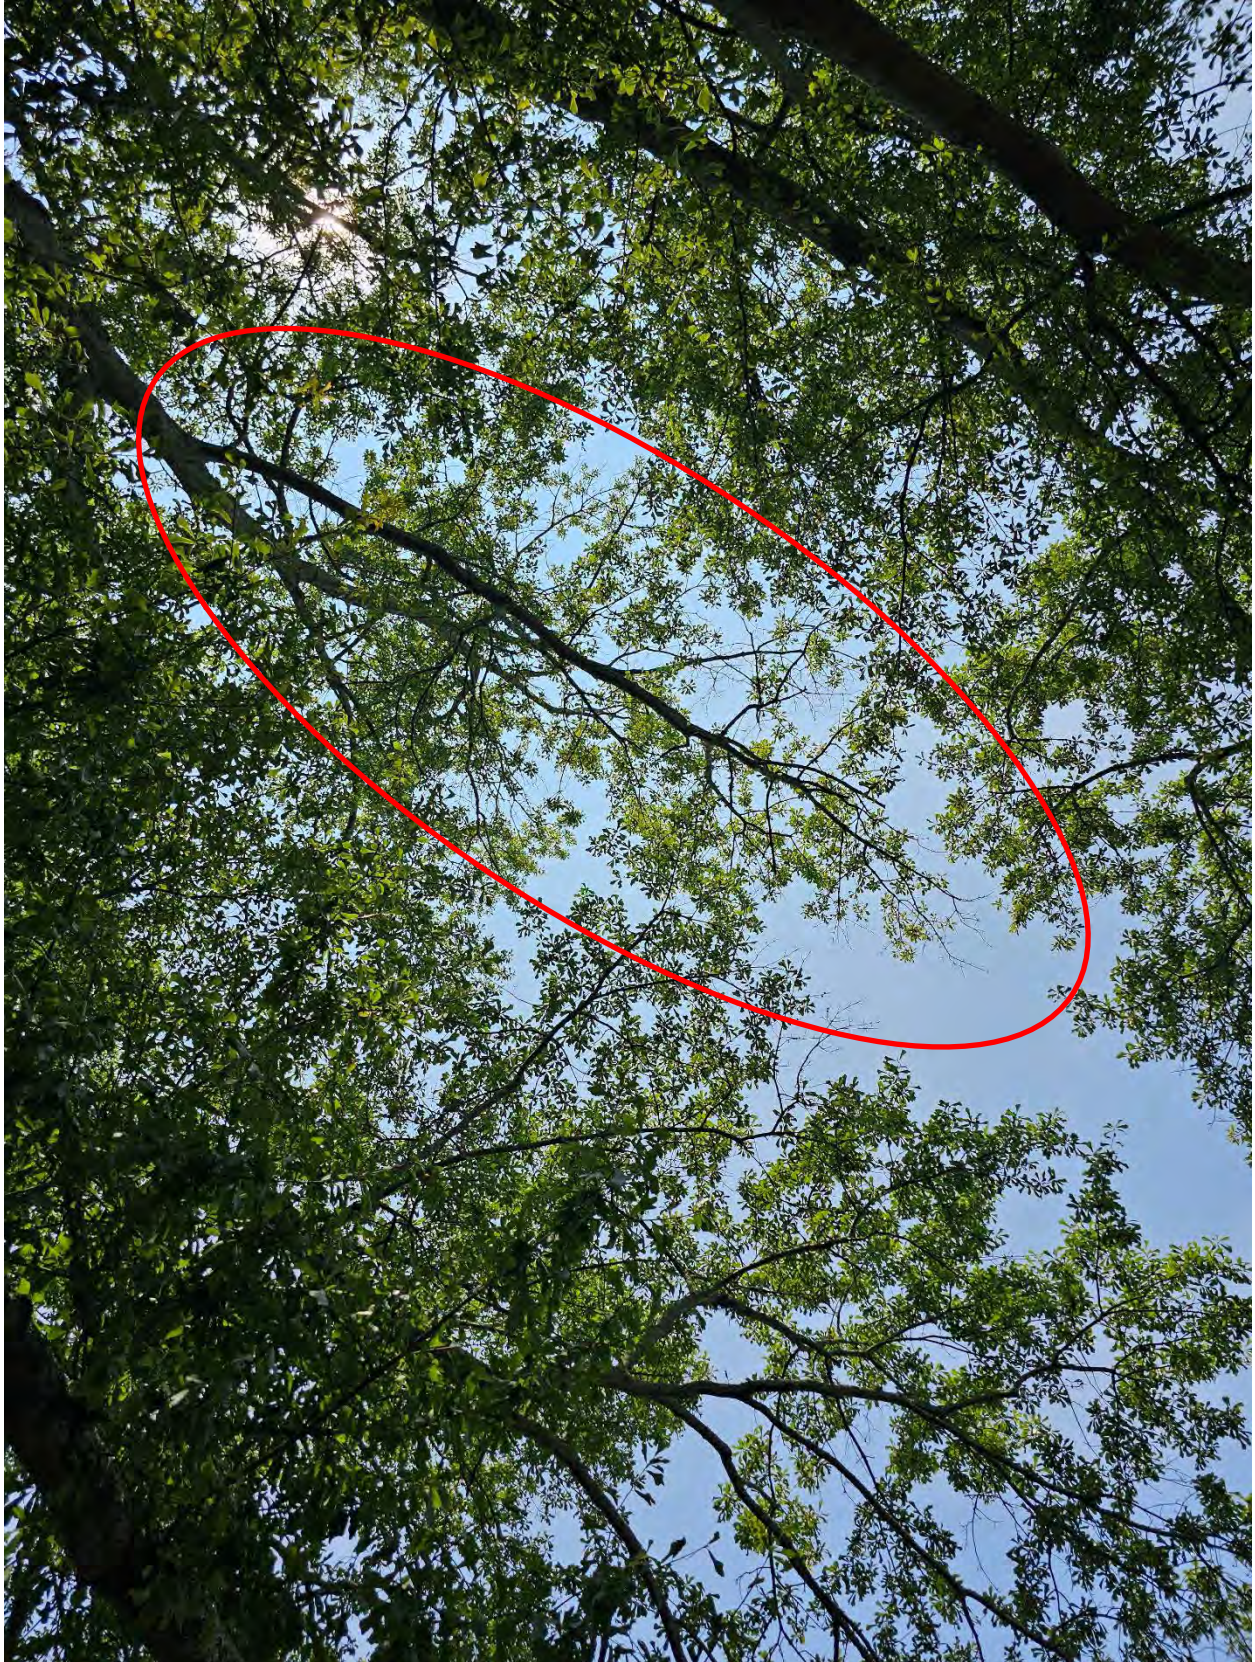
Figure 8. Major limb dieback, crown thinning, and chlorosis

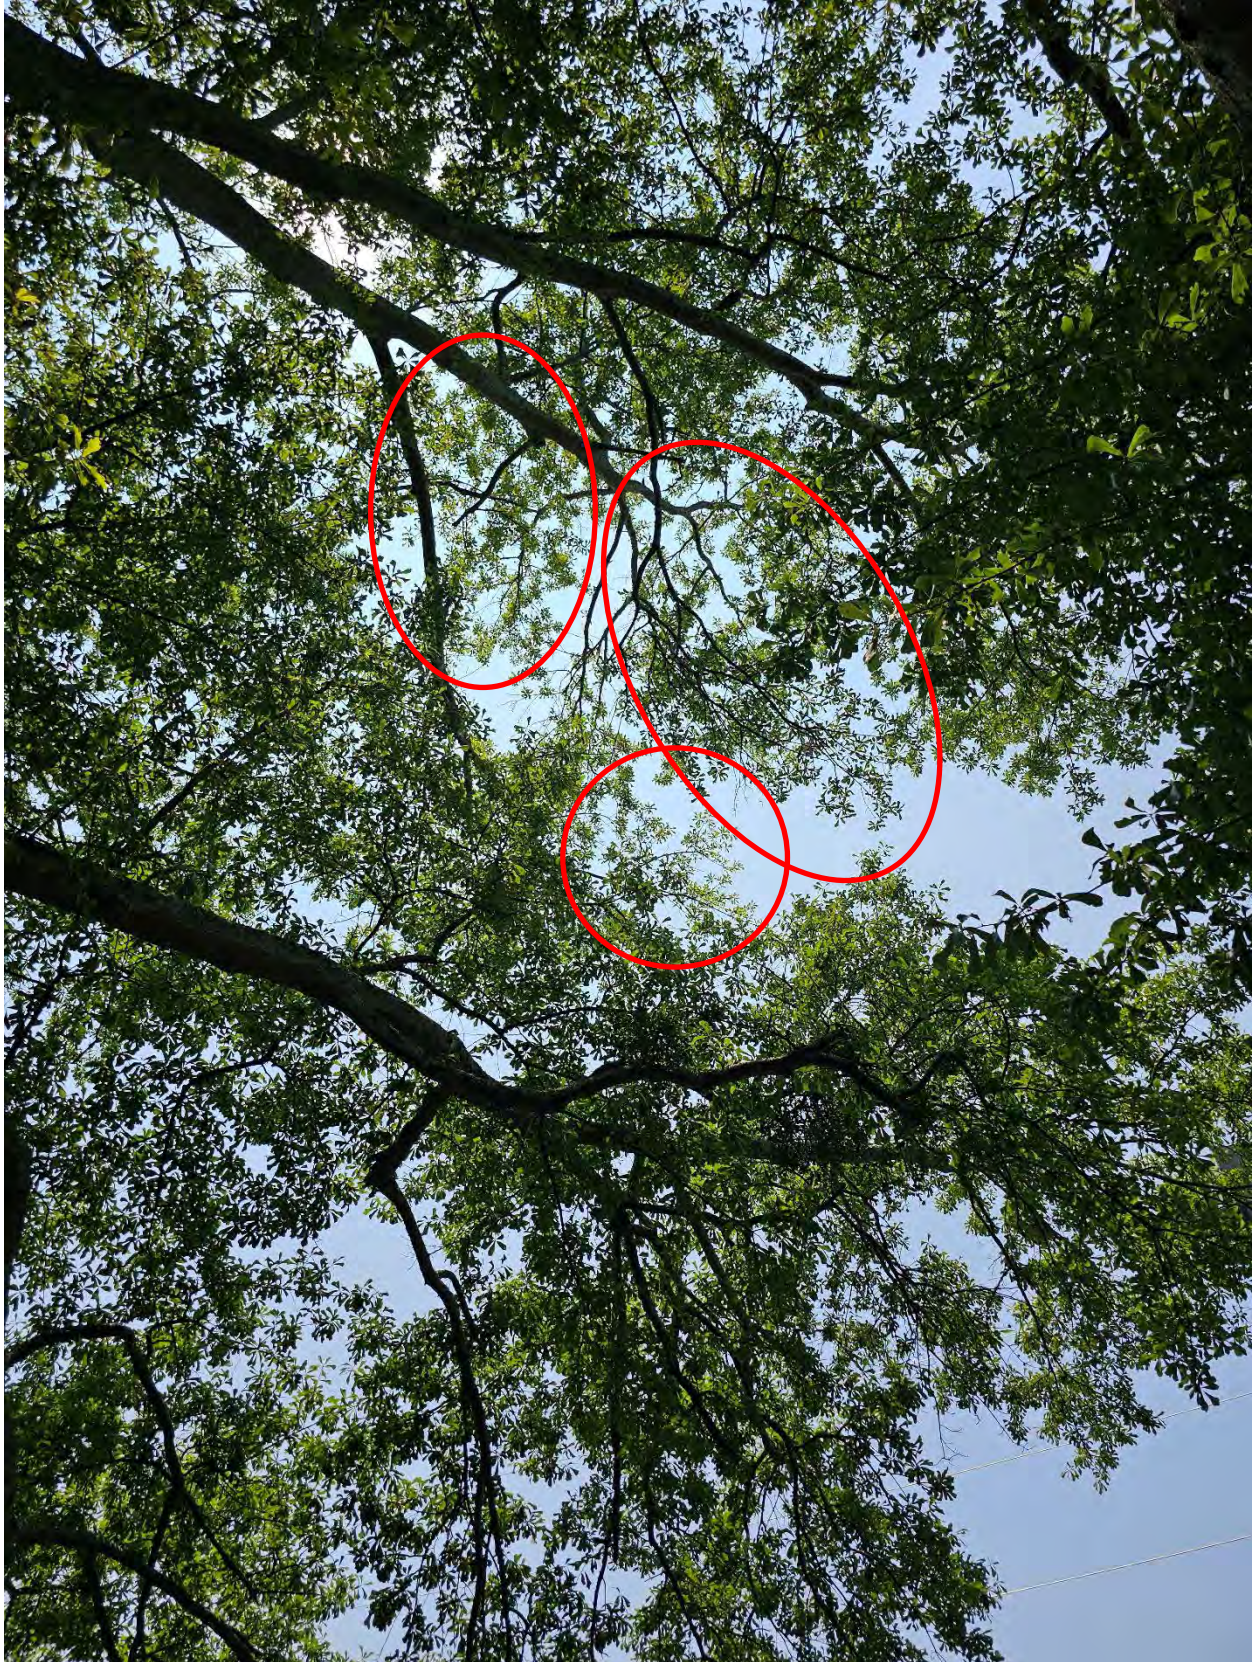
Figure 9. Major limb dieback, crown thinning, and chlorosis

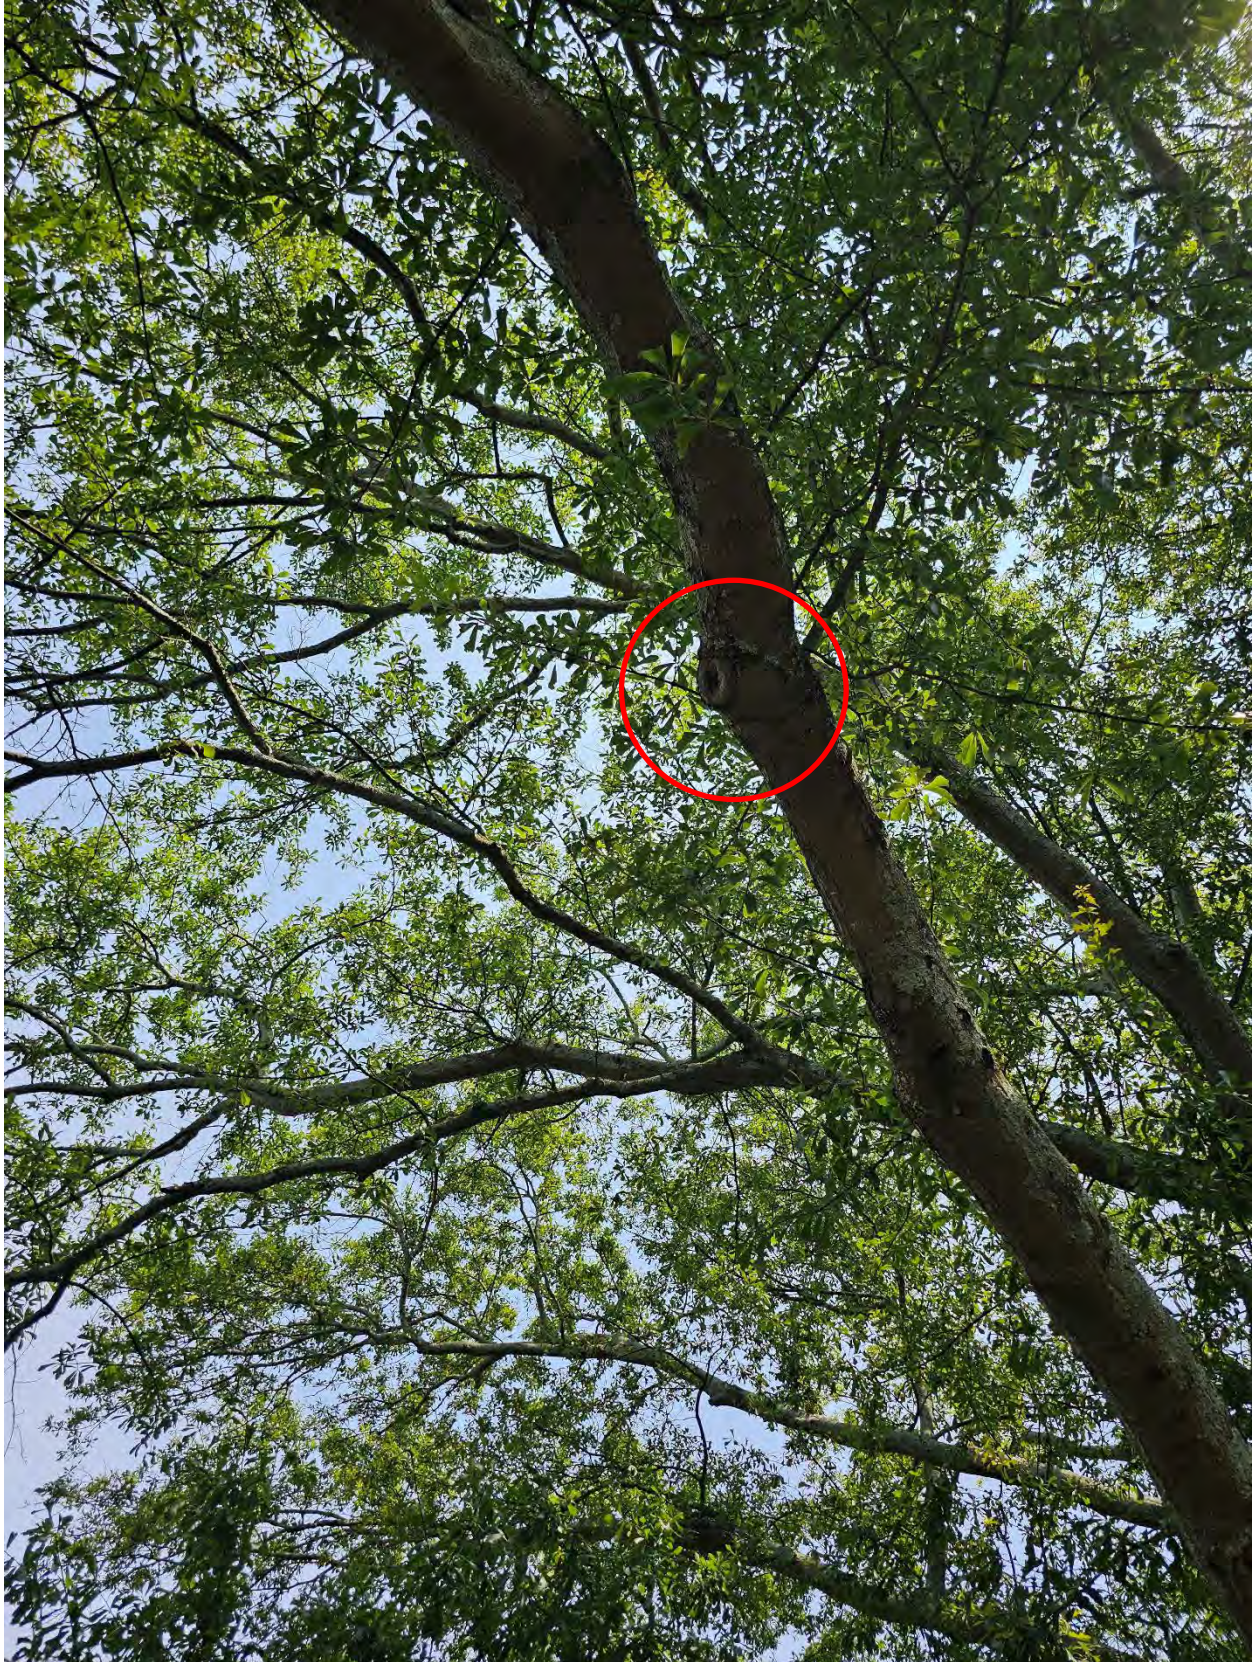
Figure 10. Decay on major limb

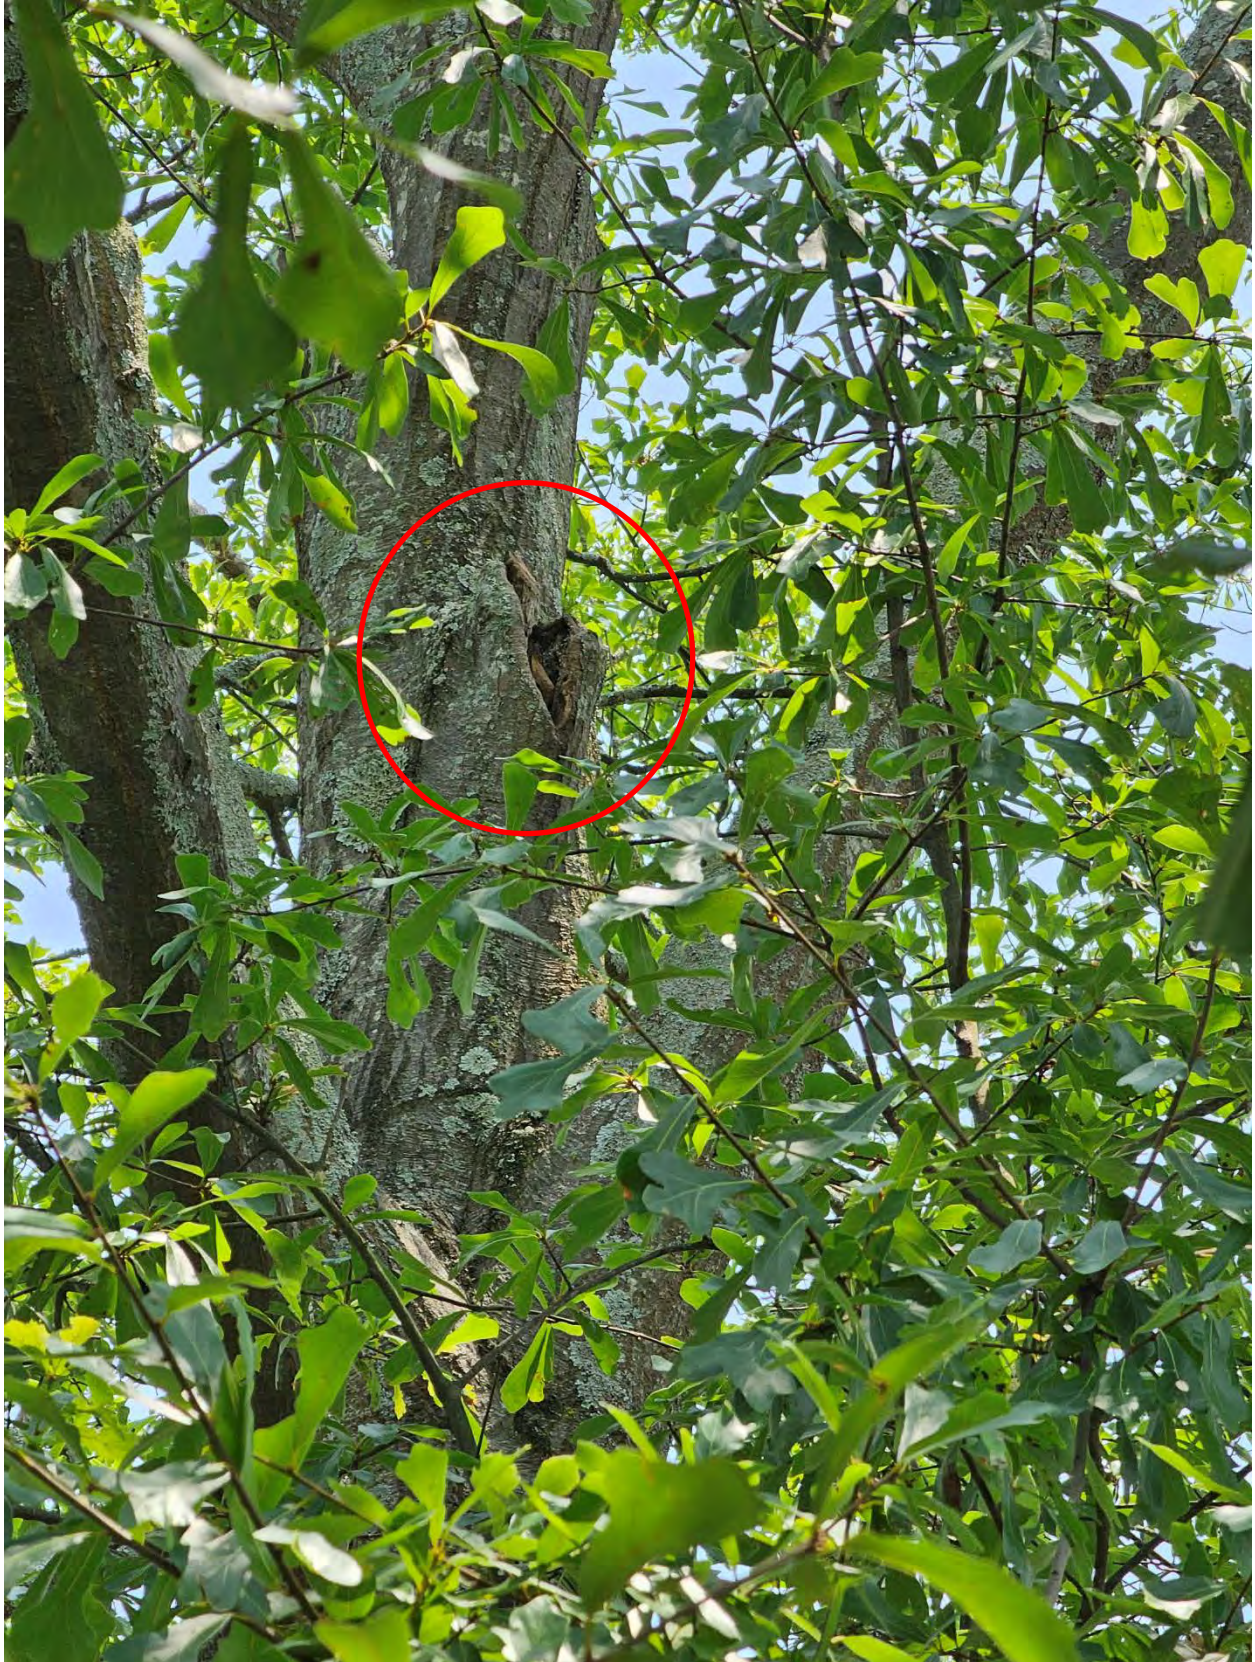
Figure 11. Decay in main stem of trunk
