ARBORIST REPORT

STATE BRIDGE RD SITE
State Bride Road
CITY OF JOHNS CREEK, GEORGIA

RE: Level 2 Arborist Inspection
State Bridge Rd – City of Johns Creek Ga Parcel: 11 094002990166

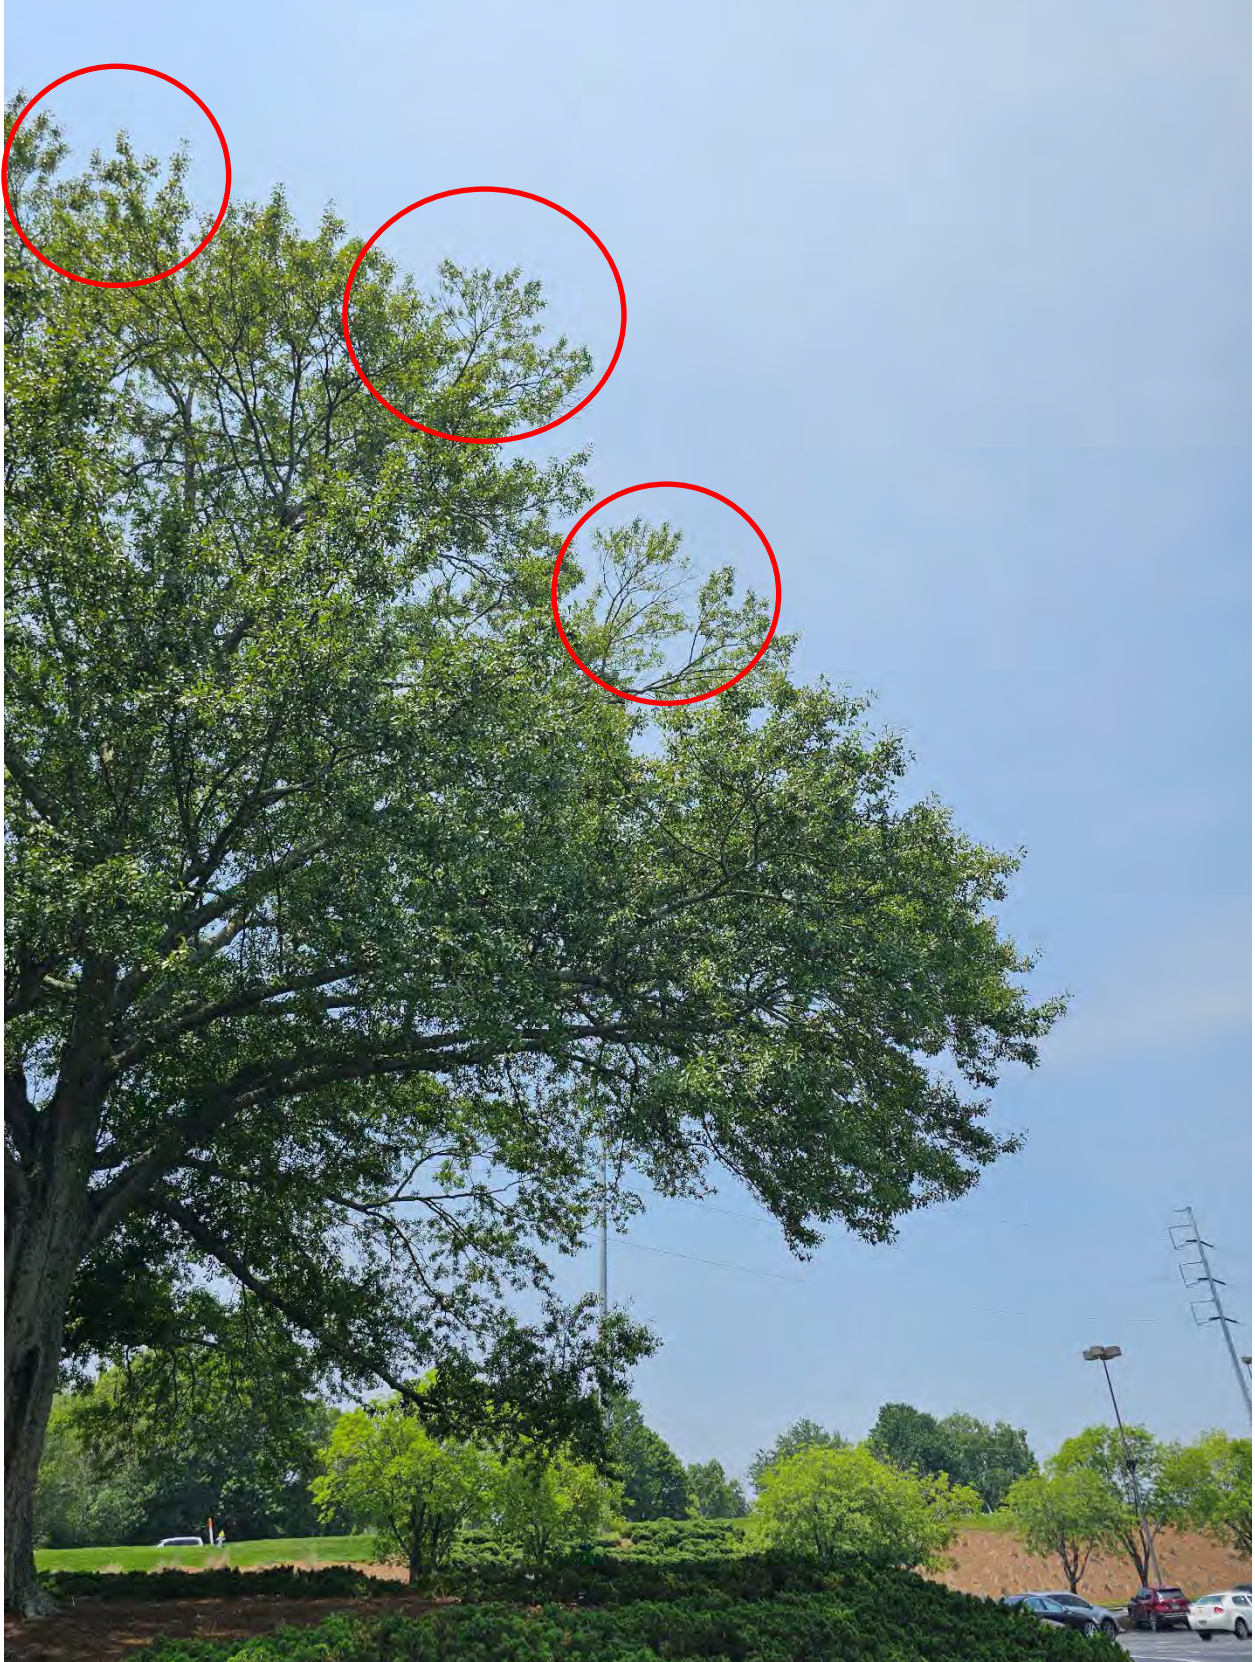
The tree was found to have a DBH of 49.5" and numerous signs of declining health. No site disturbance has occurred to affect any CRZ to the tree. While no current disturbances have occurred, it should be noted that critical root zones typically extend beyond the dripline and the impervious surfaces surrounding the tree reduce the ability of the tree to extend its critical root system. The tree has several areas of stem and limb decay as well as multiple portions of the crown present with thinning and chlorosis of the leaves. Multiple areas on the stem contain bark inclusion. **Bark Inclusions are serious tree defects that are very common, and often lead to breakage under low to medium loads.** They occur between two **co-dominant stems**, as they grow. The bark between the two stems included in the trunk, as the cambium advances year after year. This acts essentially as a wedge, pushing the stems apart, and thus producing an extremely weak union. This tree has passed the viable lifespan and has entered into decline that cannot be corrected and will ultimately die. Pictures further detailing the deficiencies are included.

Figure 12. Thinning crown and chlorosis

Due to the severity of the structural deficiencies of these trees, there is no amount of engineering design improvements that can be made to assist in the longevity of the trees. It would be recommended to remove the tree to reduce the risk to the public and replace with a species of tree that would be more appropriate.

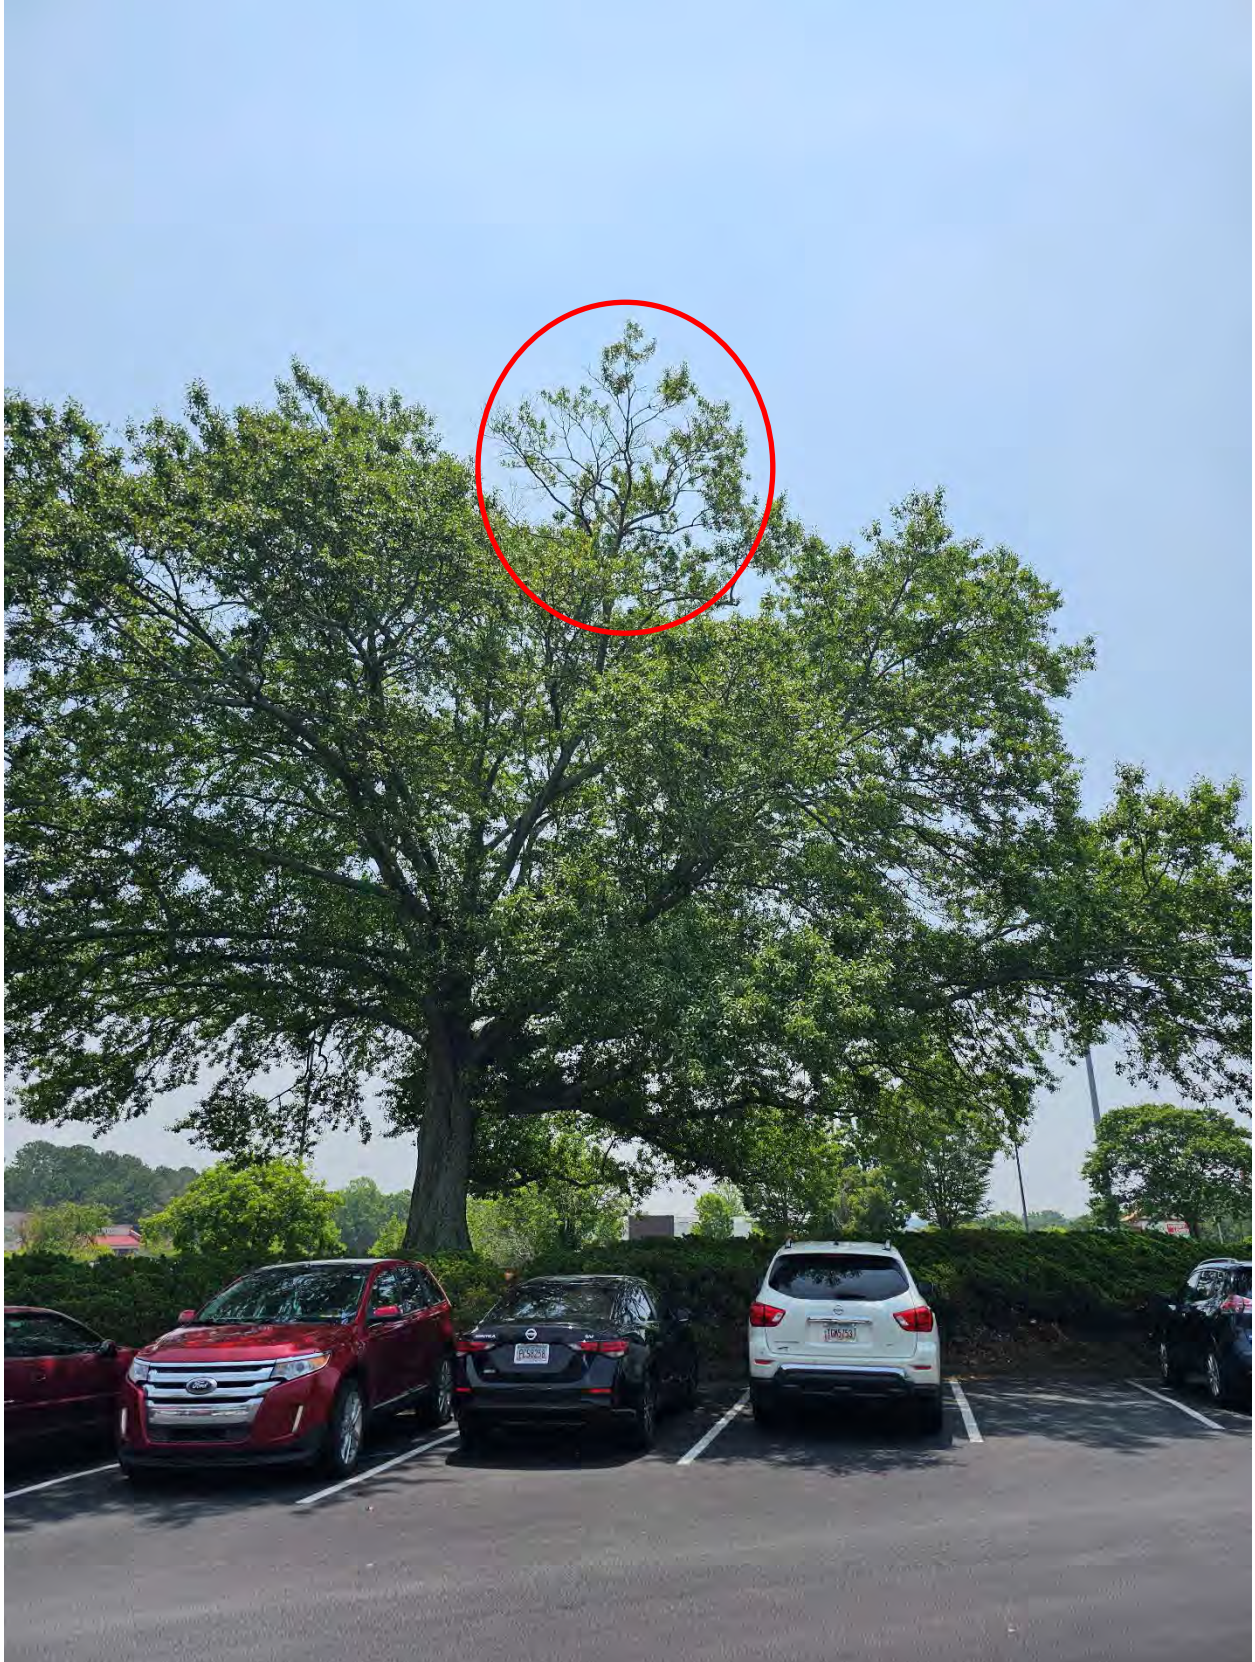
Figure 13. Thinning crown and major limb dieback
