RE: Letter of Appeal
 Stream Buffer Variance Request
 Johns Creek Town Center Stream Restoration

JOHNS CREEK STREAM RESTORATION DESIGN
50-FOOT VARIANCE REQUEST APPLICATION
SUPPLEMENTAL INFORMATION

Johns Creek Town Center Stream Restoration
City of Johns Creek
Johns Creek, Fulton County, Georgia

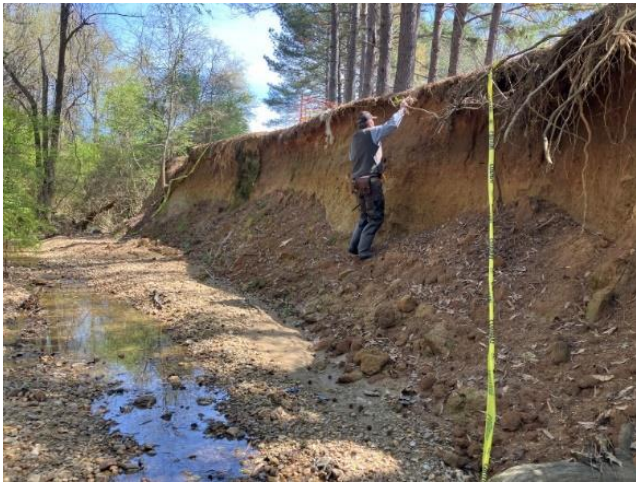
Photo 1: 10'-high eroded bank along greenway creating public safety hazard, facing upstream

The existing stream is severely eroded and deeply incised with near vertical banks. The high level of impervious surface in the watershed causes rapid runoff into the closed drainage system, and the concentration of flows into a single outfall has resulted in severe bank erosion. The severe erosion has damaged nearby infrastructure, including the existing greenway path. Bank erosion (>10 feet) along approximately 170 feet of the east bank has caused a public safety hazard, requiring the City of Johns Creek to temporarily close the greenway path.

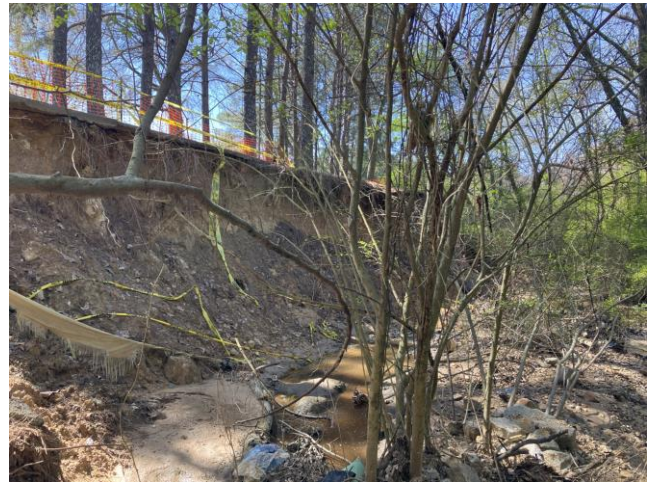
Photo 2: 10'-high eroded bank along greenway, creating public safety hazard, facing downstream
