# **Turning Performance Analysis**

**Bid Number:** 632 **Chassis:** Enforcer Chassis, Tractor (Tiller)

**Department:** Johns Creek Fire Department **Body:** Aerial, Tiller, Alum Body

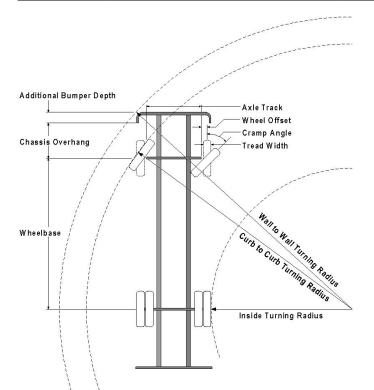
Inside Cramp Angle:	50°
Axle Track:	85.86 in.
Wheel Offset:	3.12 in.
Tread Width:	13.5 in.
Chassis Overhang:	65.95 in.
Additional Bumper Depth:	10 in.
Front Overhang:	75.95 in.
Wheelbase:	163 in.

Inside Turn:	10 ft. 7 in.
Curb to curb:	23 ft. 10 in.
Wall to wall:	27 ft. 9 in.
